Director, Operational Test and Evaluation

**RQ-21A Blackjack
Small Tactical Unmanned Aircraft System
(STUAS)**

Initial Operational Test and Evaluation Report

June 2015

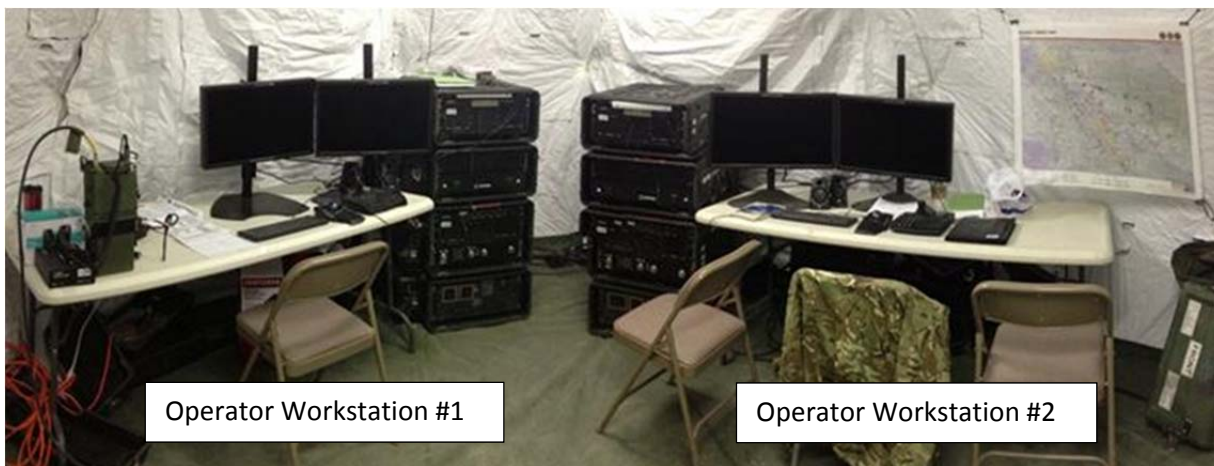
Figure 1-3. Tabletop Ground Control Station Configuration

The ground control station (GCS) is used to plan missions, control and monitor the air vehicle, and manage data received from the air vehicle. Figure 1-3 shows the tabletop ground control station configuration used during operations at Marine Corps Air-Ground Combat Center Twentynine Palms. The GCS includes two operator workstations, two ground data terminals for air vehicle command and control and video downlink, and a Global Positioning System (GPS) Electronics Module. Air vehicle operators control the air vehicle and multi-function ball turret through the GCS.

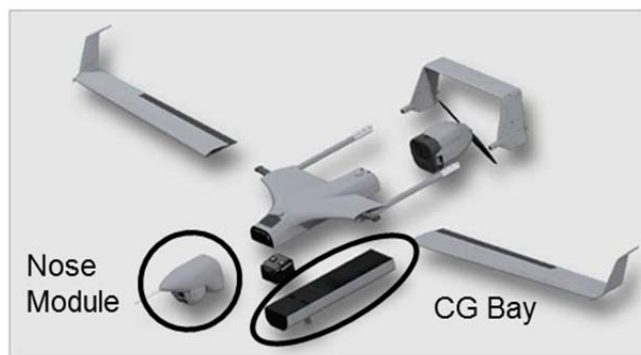
Figure 3-4. Air Vehicle Payload Modules

The modular air vehicle design allows for payload changes within the 60-minute Modular/Interchangeable Payload KPP threshold. Build-up of an entire air vehicle takes 20 minutes. As shown in Figure 3-4, the air vehicle carries payloads in one of two modules: the nose module or the Center of Gravity (CG) Bay.

The electro-optical/infrared sensor mounts to the nose module. The CG Bay carries the communications relay payload and the automatic identification system. The CG Bay will carry additional payloads in the future provided they have the appropriate interface connections.

Maintainers are able to remove and replace the nose module or the CG Bay well within the required 60-minute threshold. The nose module connects to the air vehicle fuselage with eight bolts and has a pneumatic tubing connection for the pitot systems and a serial port type connection to the avionics module. The CG bay connects to the air vehicle fuselage with eight bolts and a single power connection to the avionics module.

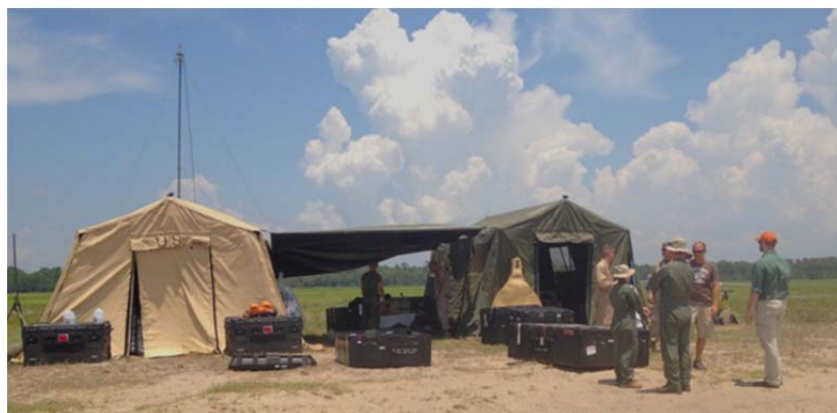
Figure 4-9. RQ-21A Expeditionary Configuration

RQ-21A support equipment does not facilitate expeditionary operations. As fielded, each RQ-21A system includes two tents used as shelter for the ground control stations. The system does not provide for inclement weather protection for air vehicles, support equipment, and spare parts. As shown in Figure 4-9, air vehicle module packing cases and spare parts would be stored under a tarpaulin strung between two tents or in the back of High Mobility Multipurpose Wheeled Vehicles (HMMWVs).
